Manhole Inspection Summary

Manhole # S63C__008MH

Insp Date: **5/29/08 1:24 PM**

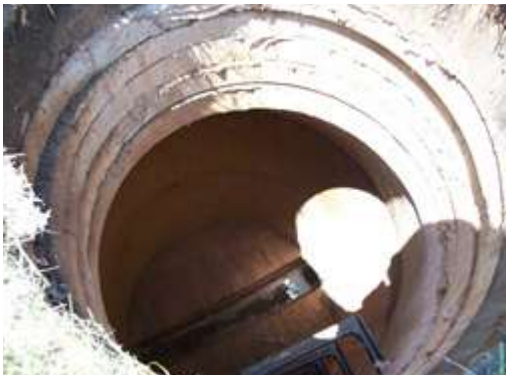
Defect 2

Infiltration: ☐ None ☐ Joint ☐ Cracks ☐ Mortar ☐ Roots ☒ **Wall**

infiltration

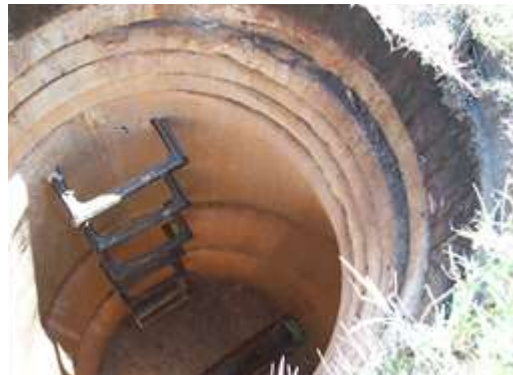
Defect 1

Infiltration: ☐ None ☒ **Joint** ☐ Cracks ☐ Mortar ☐ Roots ☐ Wall

frame leaks

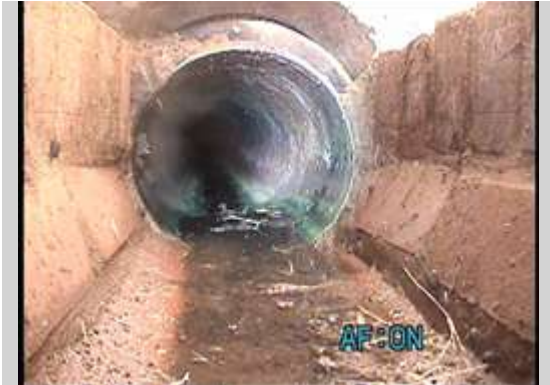
12 O'Clock Outflow

8 in. Circular Gravity Sewer
Pipe Out @ 12 O'Clock

Pipe Height: **8.4** (in.) Rod and Bar (Angled)
Pipe Material: **PVC** ☐ Pipe Lined
Invert Depth: **10.00** (ft.) Flow Characteristics: **Slow**
Deposits: ☒ None ☐ Mud ☐ Sludge ☐ Debris ☐ Grease
Silt Depth: (in.) Deposits Extent:
Infiltration: **None** Pipe Seal Cond: **Sound**

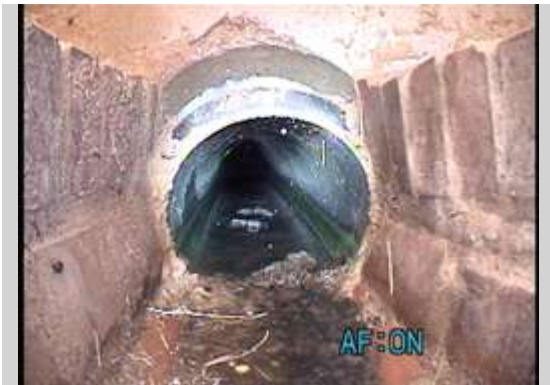
6 O'Clock Inflow

8 in. Circular Gravity Sewer
Pipe In @ 6 O'Clock

Pipe Height: **8.4** (in.) Rod and Bar (Angled)
Pipe Material: **PVC** ☐ Pipe Lined
Invert Depth: **9.90** (ft.) Flow Characteristics: **Slow**
Deposits: ☒ None ☐ Mud ☐ Sludge ☐ Debris ☐ Grease
Silt Depth: (in.) Deposits Extent:
Infiltration: **None** Pipe Seal Cond: **Sound**
